HACKENSACK RIVER BASIN

ORADELL RESERVOIR DAM

**PHASE I INSPECTION REPORT
NATIONAL DAM SAFETY PROGRAM**

NJ 00258

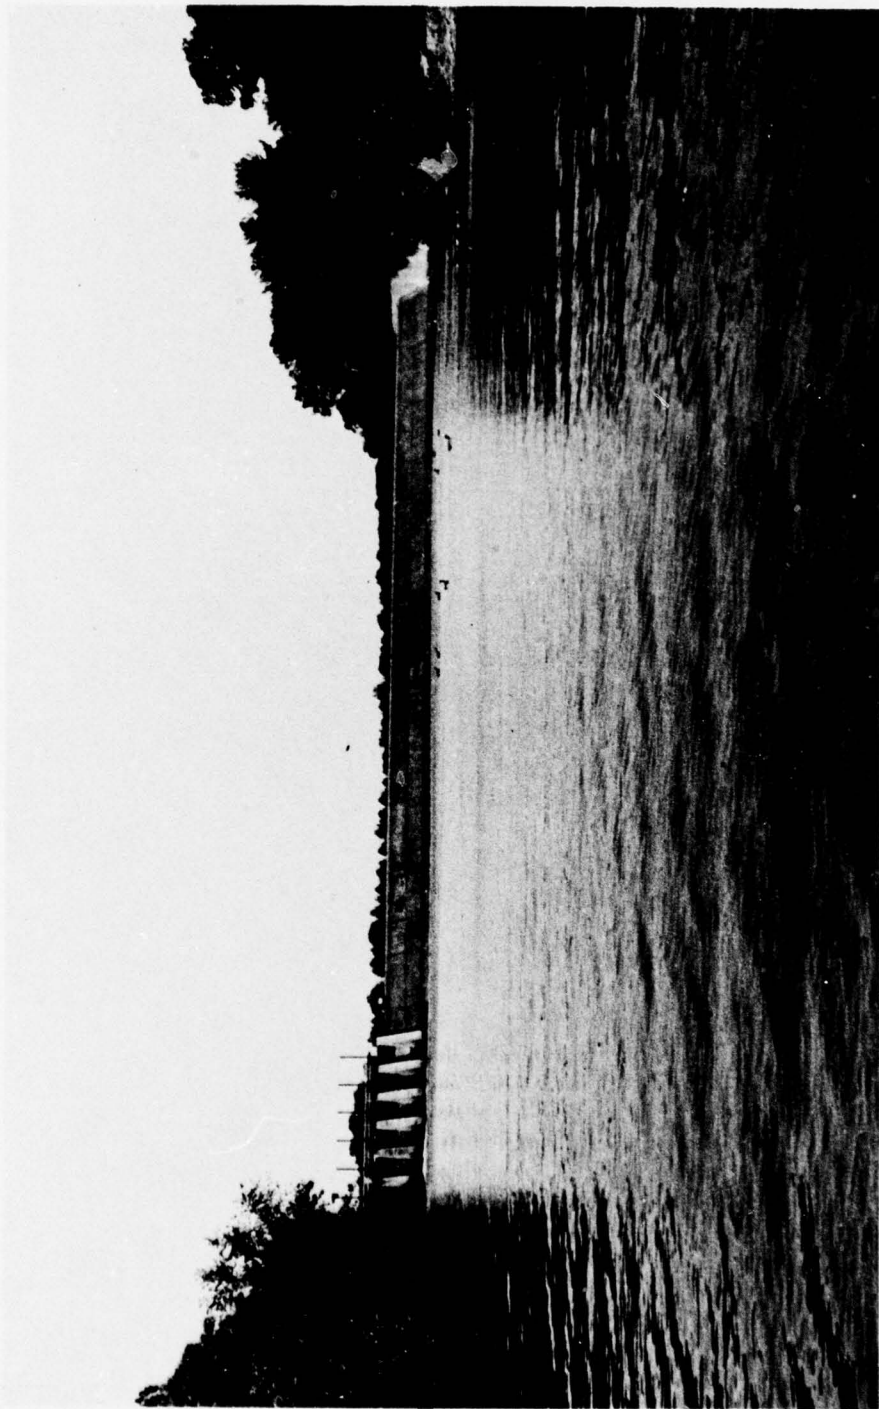
OVERALL VIEW OF DAM

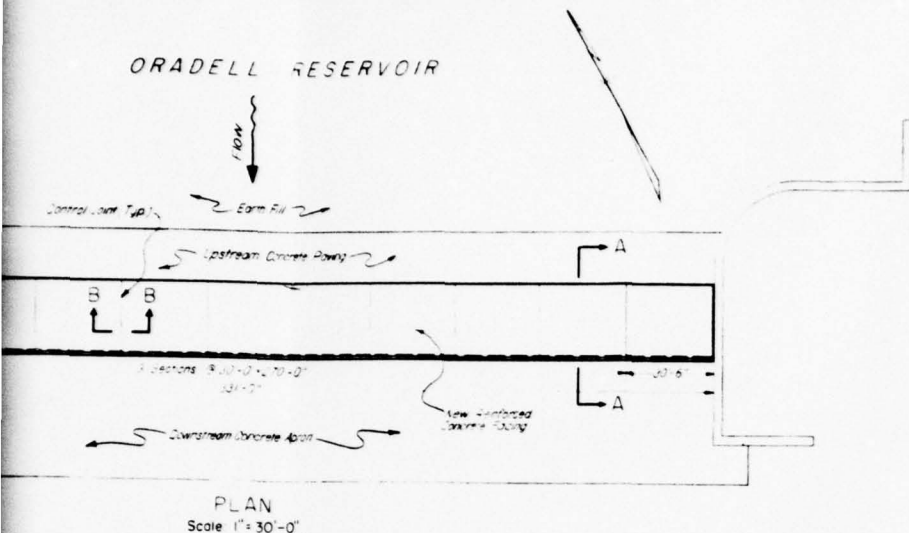
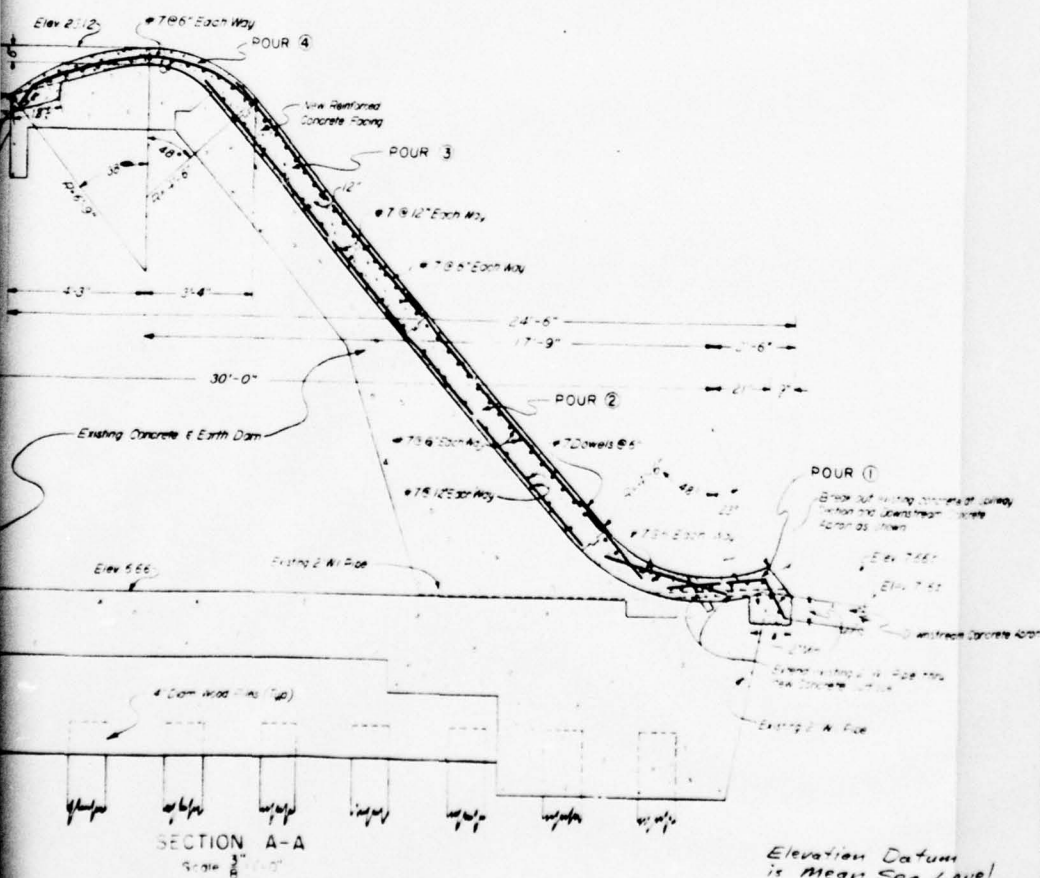
PLATE 8

Site work for Oradell Dam began in 1911 and the dam was constructed from 1920 to 1922. The only readily available source of construction information is Hill's 1926 A.S.C.E. paper referenced above. Microfiche files of the N.J.D.E.P. contain limited additional construction information. The concrete weir section was resurfaced in 1965 (see Plate 8).

- c. Operating Records - Nothing in the readily available operating records suggests structural inadequacy of the dam.
- d. Post-Construction Changes - The only post-construction change of structural significance was resurfacing of the concrete weir envelope in 1965 (see Plate 8). This resurfacing improved structural stability of the dam by an indeterminate amount.

Sluice gate operation was changed from manual to electrical in 1959. Some repairs were made to downstream face of dam in 1960. An eight inch reinforced concrete mat was placed on the downstream face of the dam spillway in 1965. (See Plate 8 of this report).

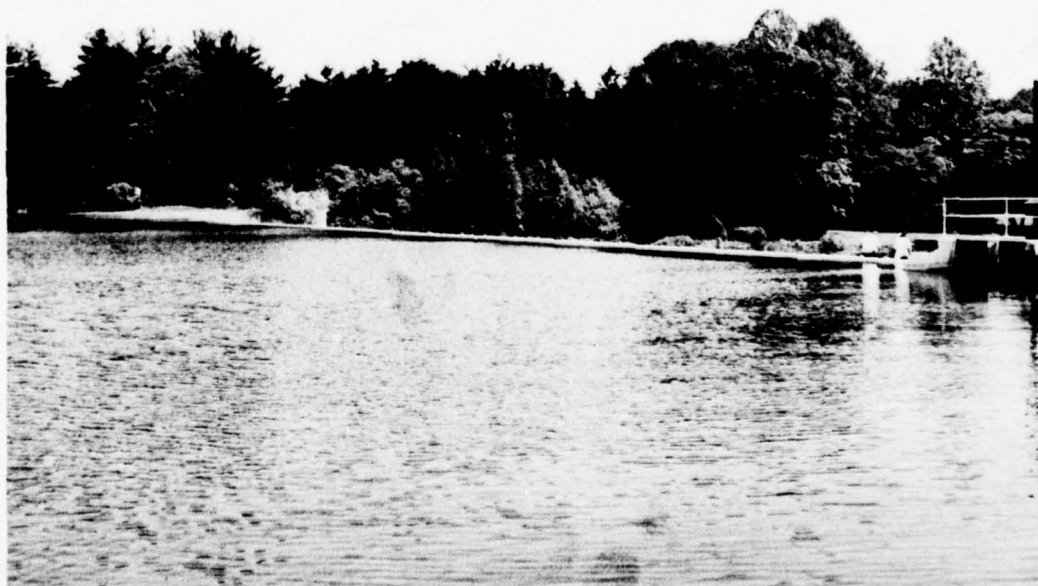
PHOTO 2

Photo 2 - View Downstream (Southeast) Over Crest of Spillway Weir From Approximately 100 Feet Upstream of Right (West) Abutment; Left (East) Abutment at Left Edge of Photo; Sluice Gates at Right Edge of Photo - 12 June 1978

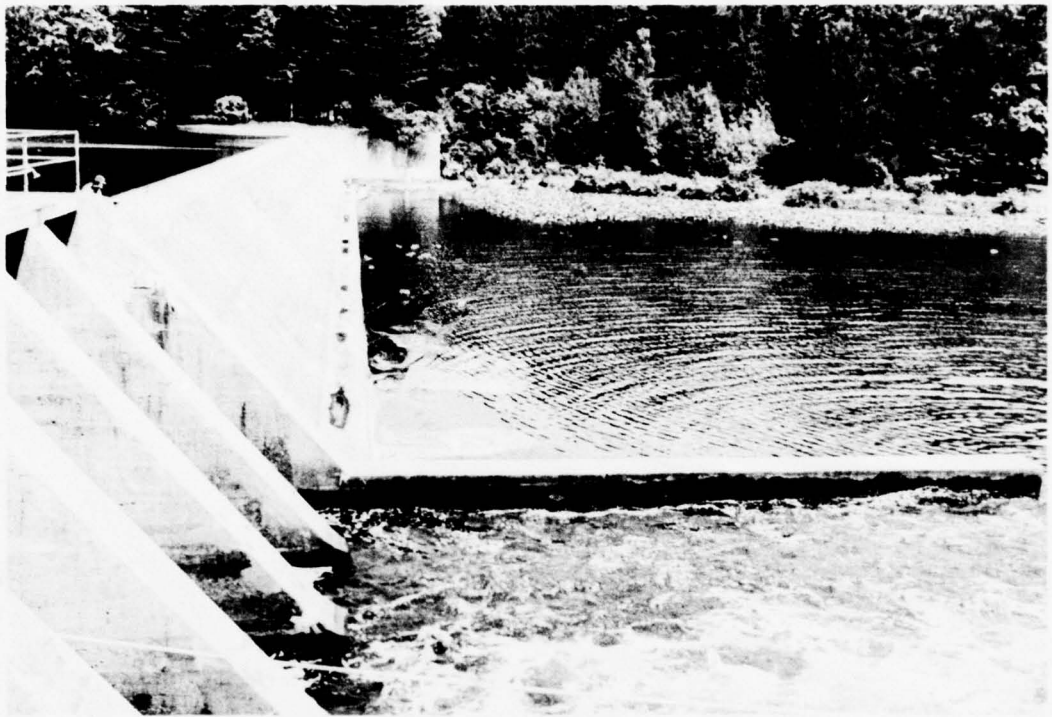
PHOTO 3

Photo 3 - View East Across Downstream Face of Dam From Right (West) Abutment; Sluice Gates at Left Side of Photo; Spillway in Left Center; Left (East) Abutment Wing Wall in Top Left Center (Close-up in Photo 4) - 12 June 1978

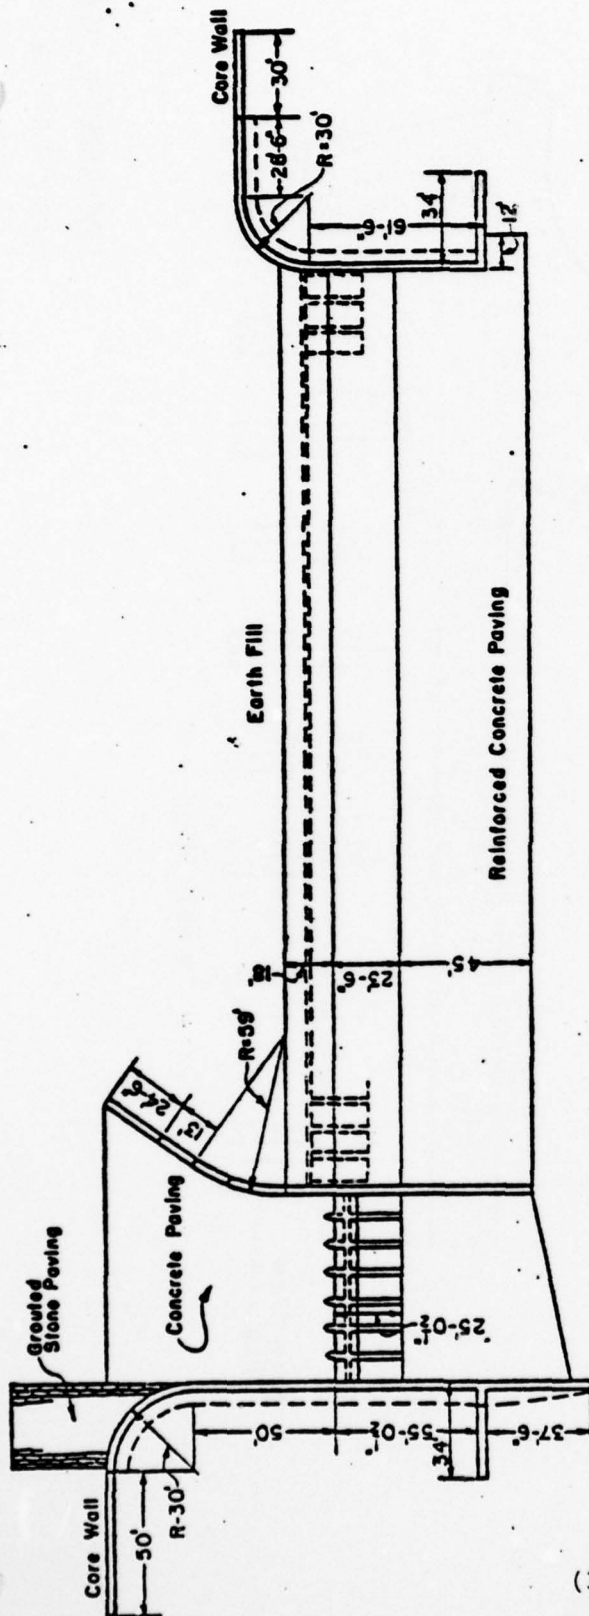
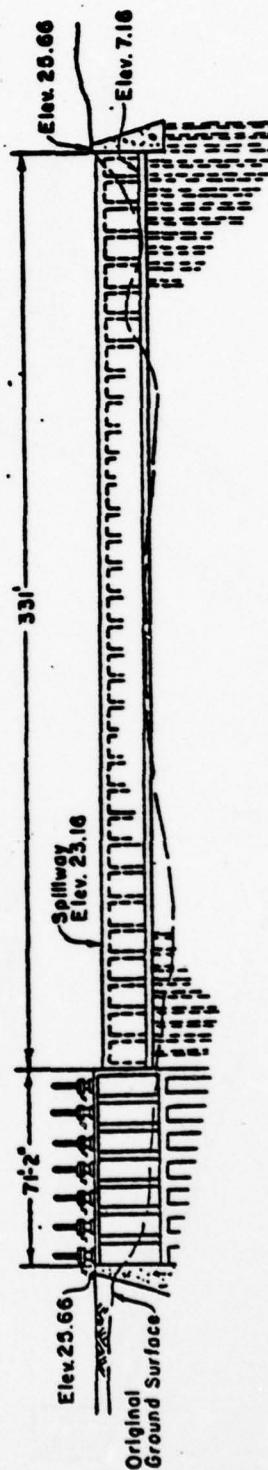
ORADELL DAM
PLAN AND SECTION
Scale 1"=60'

The condition of the structure was examined in the field. No evidence of unsafe conditions or inadequate maintenance was noted. The sluiceway as well as the surrounding lands and railroad is bound to be flooded in major floods since there is no way to increase the capacity of the spillway. In major floods power might fail

and the sluice gates, which have considerable capacity, could not be operated. We recommend that an on-site auxiliary power plant be installed for emergency use. Or the sluice gates could be converted to hydraulic operation so that they could operate inundated.

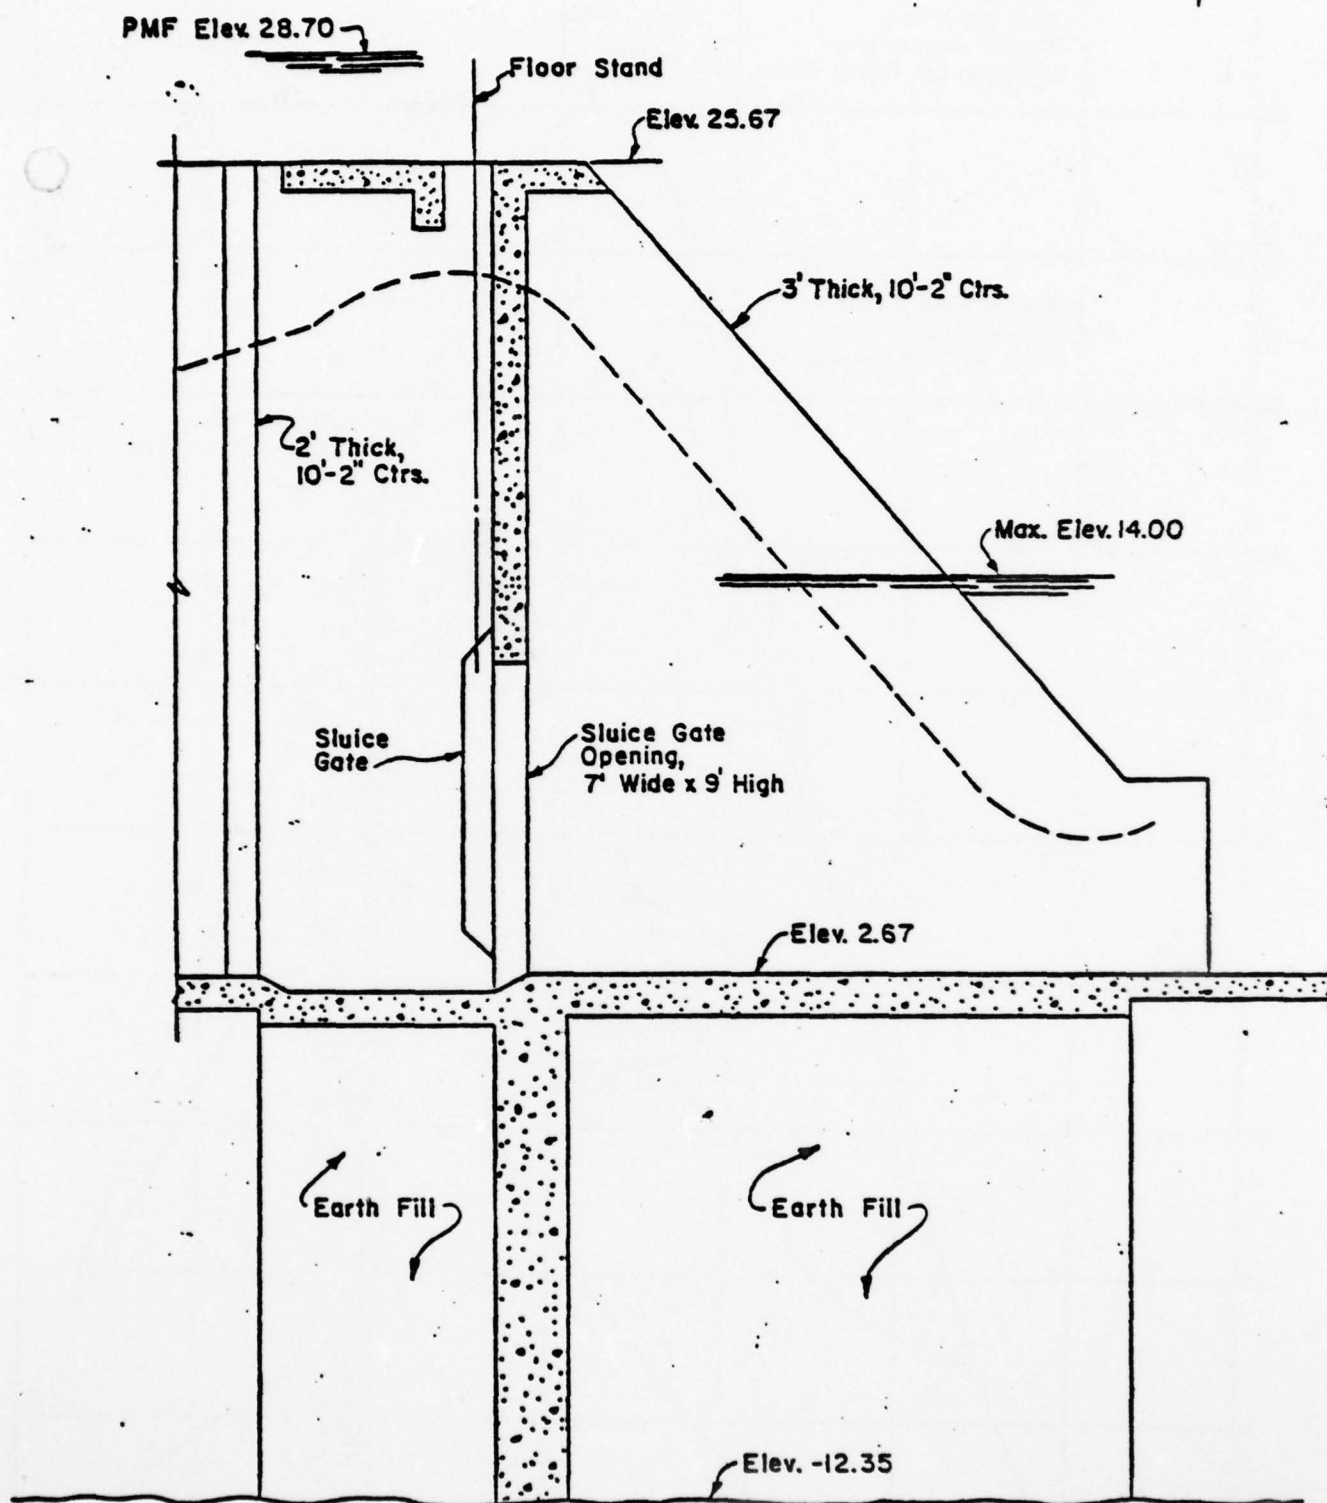
ORADELL DAM
SLUICWAY SECTION
Scale: 1" = 5'

Stability analyses of the spillway section and of the sluiceway were made for peak outflow conditions. Details of the computations and the resultant forces and their locations are presented in Appendix B. Stability of the spillway section is excellent as the resultant falls within the middle third of the base. Sliding resistance is ample without the shear resistance of the piling. Stresses are low and are positive, with the load on the foundation assumed to be carried entirely by the piers. Sliding resistance of the sluiceway is satisfactory when passive resistance of the backfill is taken into account. Stresses are low. A small amount of tension exists on the highest pier. However, this pier adjoins the spillway section which has piling. The resultant falls slightly in the downstream third of the base which indicates a small amount of tension but not overturning. The position of the resultant is more favorable as the piers reduce in height.

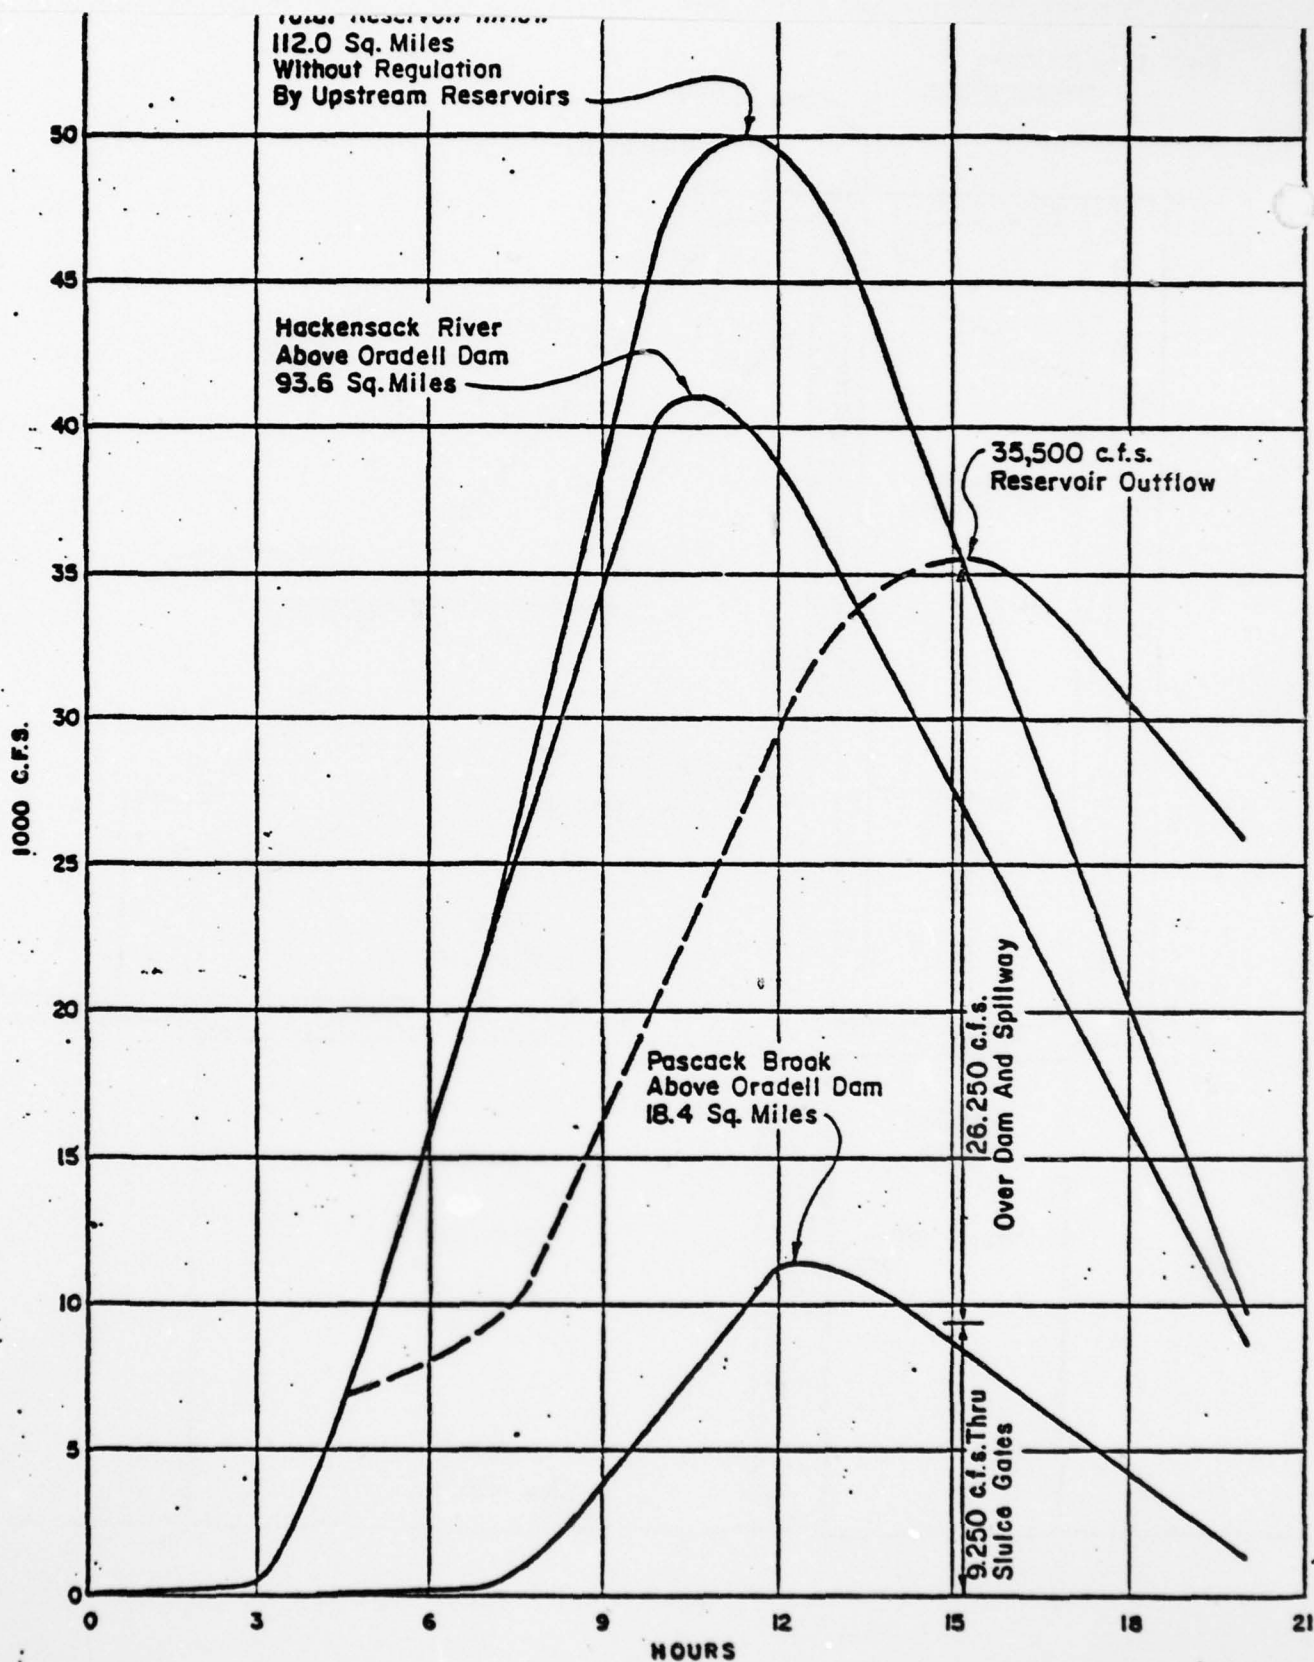
ORADELL DAM
PROBABLE MAXIMUM FLOOD
INFLOW AND OUTFLOW HYDROGRAPHS

The reservoir inflow flood peak under probable maximum flood-producing conditions is estimated to be 50,000 cfs, equivalent to 446 cfs per square mile from the 112 square mile drainage area. A peak flow of this magnitude would be produced by 17.05 inches of rainfall occurring in 6 hours. Computations of the probable maximum precipitation and the corresponding probable maximum flood for the watershed tributary to Oradell Dam are presented in Appendix A. The reservoir inflow hydrograph was computed first for the entire drainage area and then by combining separate computations of flow from Pascack Brook with that from the remainder of the watershed. The latter method produced a slightly higher peak inflow and was selected for routing through the reservoir. Reservoir inflow and outflow hydrographs for the probable maximum flood are shown on page 33. The peak outflow over the dam would be 23,500 cfs if 7,000 cfs passes through the

sluices. This would produce a water depth of 5.74 feet on the crest of the spillway. The corresponding differential head of 14.9 feet on the sluice gates would cause a flow of 9,500 cfs through the gates instead of 7,000 as assumed. Hence it is necessary to cut and try to obtain a balance in flows. Figures that satisfy this are 26,250 cfs over the dam and 9,250 cfs through the sluices with the tailwater at elevation 14.0. The head on the dam crest would be 5.54 feet, equivalent to a reservoir water surface at elevation 28.70. At that elevation flow would be passing over the sluice gate structure and over the adjacent lands and railroad.
